LEARNINGS FROM AMRI HOSPITAL FIRE
KOLKATA

Date: 09.12.2011

Date and Time of Incidence : 9.12.2011 at around 0230 Hrs
Location : AMRI Hospital Kolkata
Type of Incident : Fire in the building causing multiple casualties

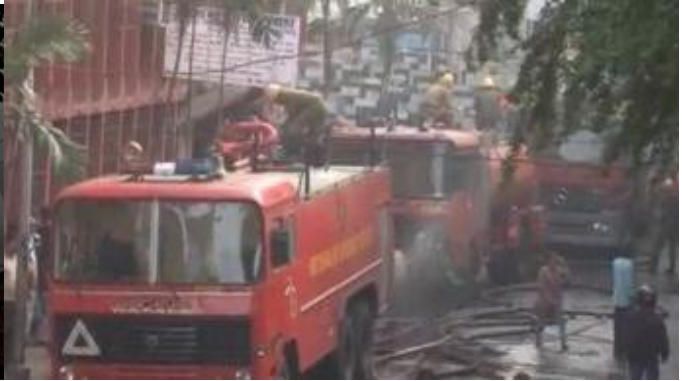
- The Fire Brigade vehicles could not reach closer to the building since the approach route was halved due to DG set installation and Gas Bank and emergency vehicles could not turn through the narrow passage.

Fire vehicles standing outside the premises unable to enter

- Fire vehicle approach: Approach and peripheral roads to be designed to cater 20 meter turning radius for Fire Tender / Hydraulic Ladders and should be capable of taking 40 tons load of Fire VehicleS.

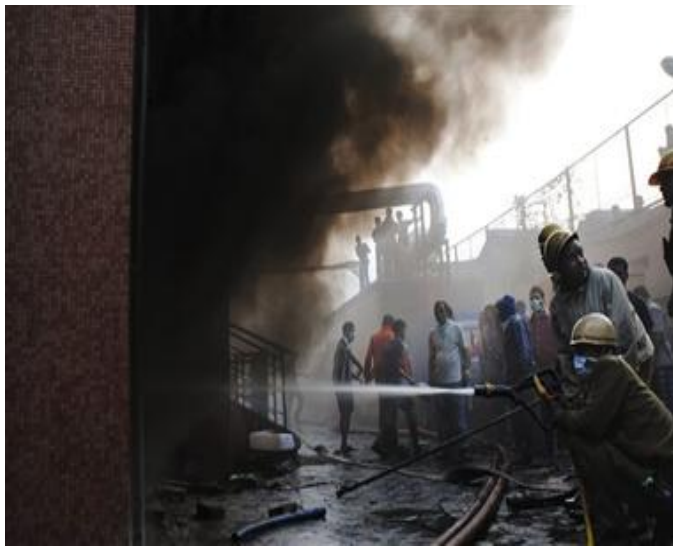
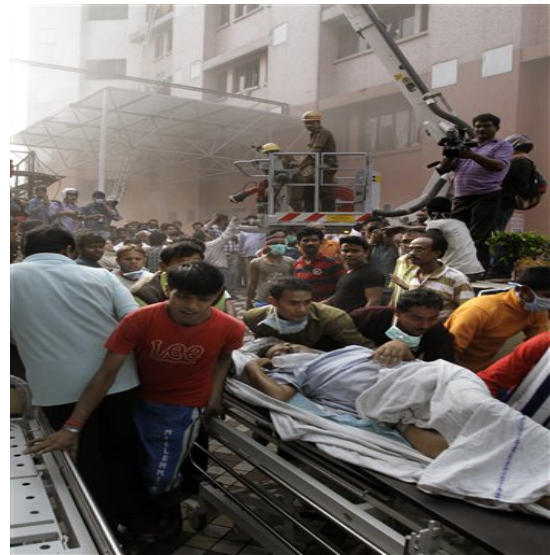
- The basement was converted into pharmacy and godown stacked with highly combustible materials. It was learnt that even oxygen cylinders / LPG cylinders were found stored in the basement.

Black dense smoke suggesting presence of hydrocarbon / PVC. Chaos outside the building

- Basement: Proper mechanical ventilation and smoke exhaust system to be installed in basement to avoid smoke logging. No combustible materials to be stored in it. Any type of modifications to accommodate storage of consumables / stationery etc will be forbidden.

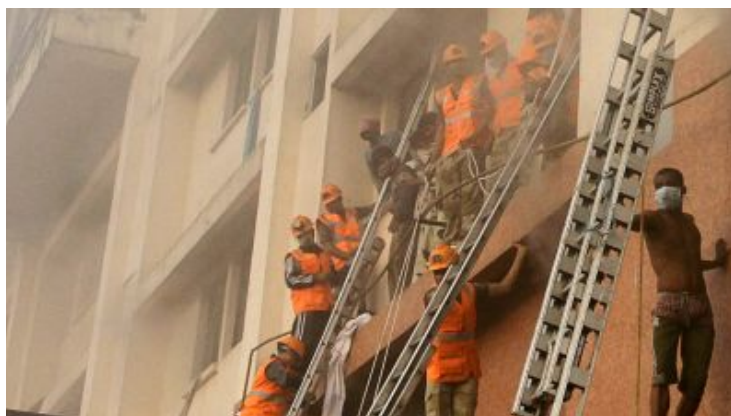
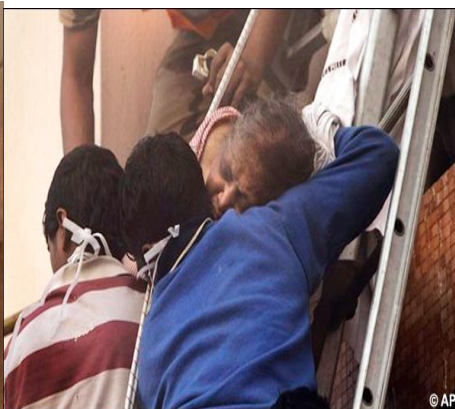
- Emergency lighting too did not work / nor was adequately available resulting in total darkness inside the building hampering rescue / firefighting. Nobody started rescue operations using internal staircases / lifts ramps due to pitch darkness and presence of dense smoke at early crucial stage. The staff was untrained and was unaware of any emergency preparedness.

Rescue from outside of the building. No use of internal staircases ramps due to smoke logging / darkness

- All emergency staircases and lifts should open in enclosed lobby (that can be pressurized by blowers upon activation of fire alarm) to avoid vertical smoke and flame travel. At least one emergency staircase shall open directly outside building at Ground floor for safe evacuation and rescue.

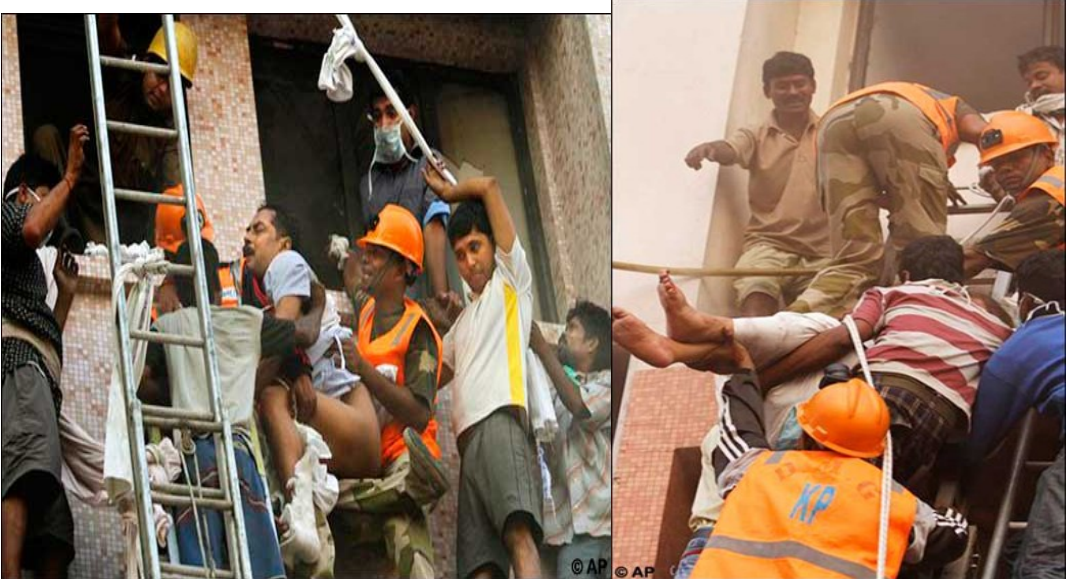
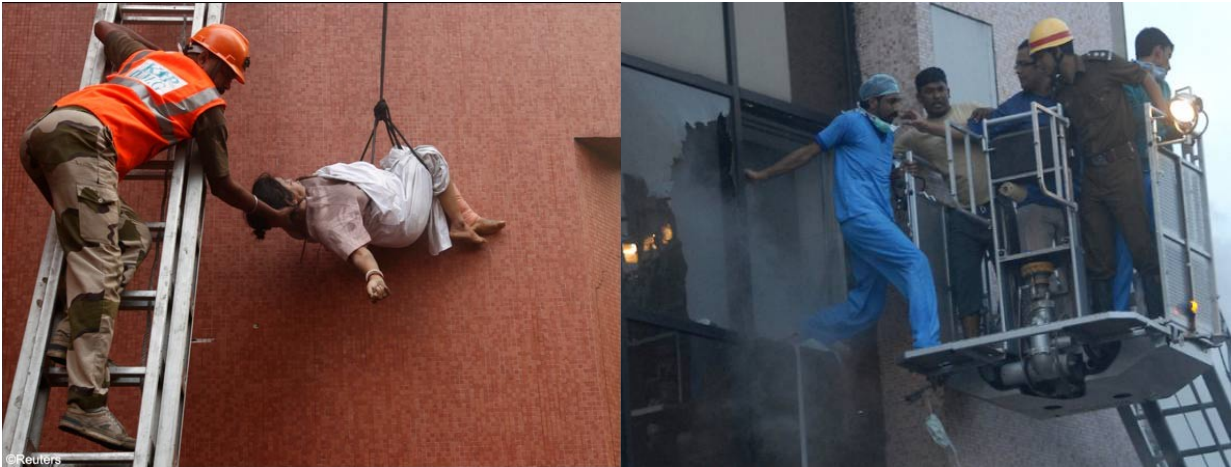
- The rescue operation was seen being carried out using rope -ladders from outside the building reaching to the trapped personnel by breaking the façade glasses. Though this saved many valuable lives but the technique used to rescue was hilarious / dangerous. Few patients were found jumping on hydraulic platform from the window.

Rescue techniques used for evacuation though saved the lives; but a very rudimentary way due to darkness inside the building.

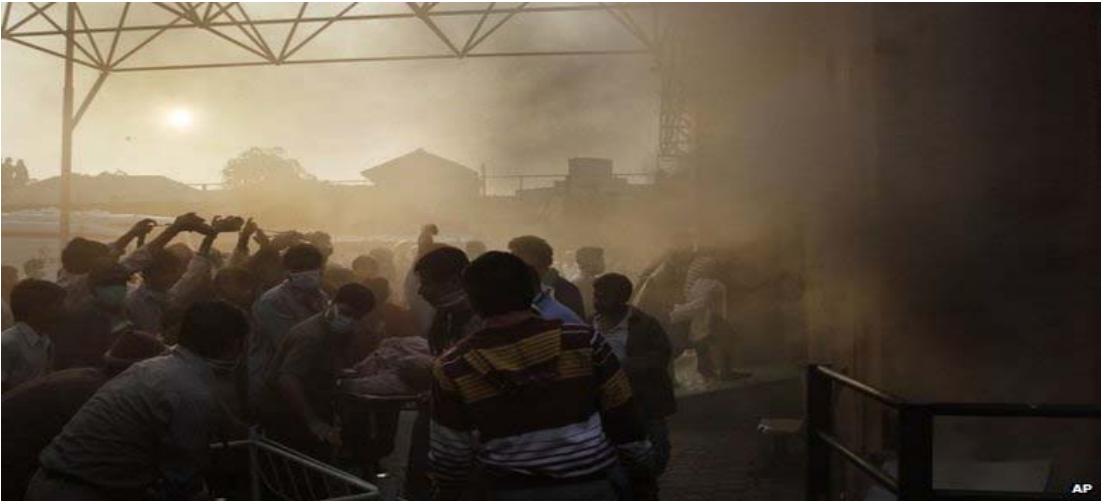
Pitch darkness and smoke logging inside building making rescue operation difficult.

- Firefighting / life safety systems to be commissioned and to be maintained in a Ready to Operate condition all the time
- Emergency power: Reliable source of emergency power to be installed in the building at par with the codes and practices (Use of MI cables may be made compulsory) so that even if main power source is switched off , life safety systems, lifts, emergency lighting, peripheral lights etc shall be provided with un interrupted power. This shall ensure rapid and effective emergency response.
